MODEL FT-1518 CCD DE MATTIA FLEX CRACKING TESTER

UESHIMA SEISAKUSHO CO., LTD.

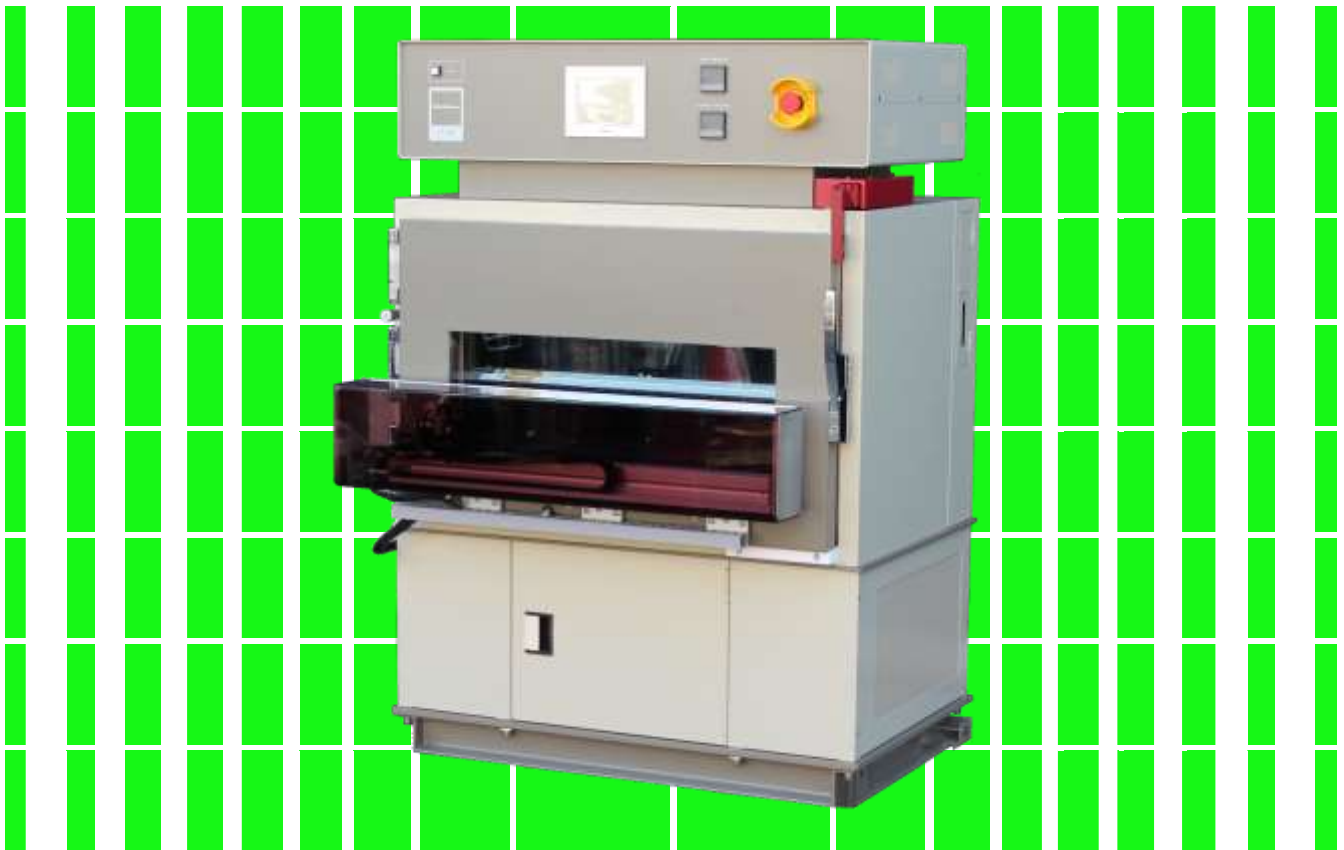
This equipment has a temperature chamber, in which it applies repeated flexures on 20 test samples and captures images of cracks generated by the mechanical fatigue and growing on the samples using a camera to evaluate durability of the samples. It stops in every preset interval to capture images and store them on a PC. Crack width can be measured automatically^(*) or manually. In manual mode, measurements can be done with a mouse on a captured image. Data can be edited afterwards. It is possible to draw a S-N curve showing crack width over the number of flexures.
